PROPAGATION AND FIRE TESTS CONDUCTED ON A SECONDARY STEEL CONTAINER DESIGNED FOR MOVEMENT OF CHEMICAL AGENT ARTILLERY PROJECTILES

DANIEL B. HILL
Ammunition Equipment Directorate
Tooele Army Depot, Utah

Presented at:
TWENTY-FOURTH DOD EXPLOSIVES SAFETY SEMINAR
Dept. Of Defense Explosives Safety Board
St. Louis, Missouri
28-30 August 1990

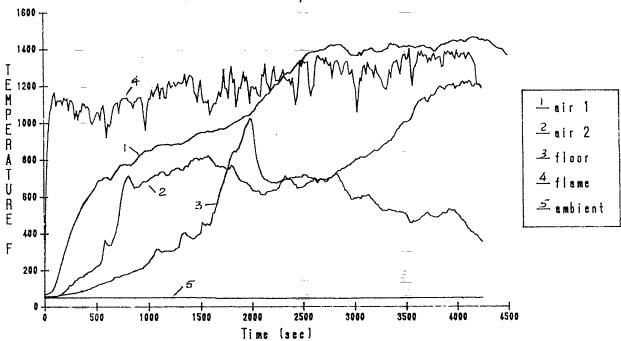
Test 2 CONEX Temperatures

A review of the video reveals that at about 25 minutes into the burn, the wood floor within the enclosure started burning and within a few minutes flame could be seen at the top corner of the Conex. The Conex floor and one air temperature curve reflect a drastic increase in temperature. SSC Temperatures show a quick rise in the SSC door temperatures (inside & outside), indicative of the fact that the flame engulfed that side of the Conex more than the other. SSC air temperature curve reflects a relatively normal rise as does the SSC exterior side wall temperature. The SSC floor and interior wall temperatures show a dramatic rise, initially corresponding to the rise in Conex floor temperature and then probably sustained by combustion of wood within the SSC. The Projectile #1 temperatures do not have a curve for the burster top, which was lost when dumping data from the datalogger to the computer; however, the liquid cavity temperature shows the same sharp rise seen in the subsequent curves for Projectiles 2 &

3. The exterior temperatures for the projectile bodies seem to follow the rise in the SSC floor temperature (resulting from combustion of wood within the SSC), which eventually catches up to the SSC air temperature. The interior temperatures, however, (liquid cavity and burster top) appear to have reached a critical temperature just prior to 2000 seconds where an exothermic degradation process begins in both the explosive and the ethylene glycol fill which drives those temperatures to 1500° F before leveling off. The reaction continues at a much slower rate until detonation.
